# Navigation Conditions at Bonneville Locks and Dam, Columbia River

by Ronald T. Wooley

U.S. Army Corps of Engineers Waterways Experiment Station 3909 Halls Ferry Road Vicksburg, MS 39180-6199

Final report

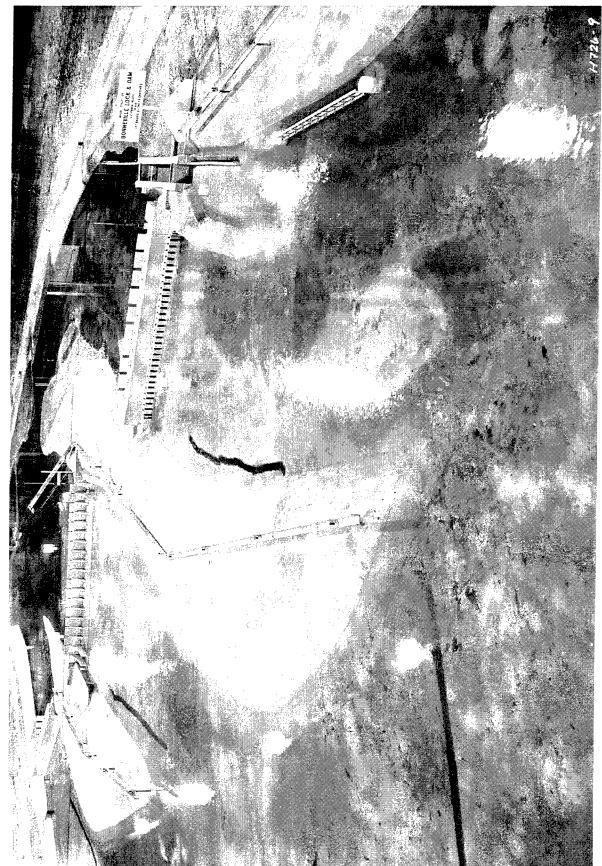
Existing structures, looking upstream from left to right, second powerhouse, spillway, first powerhouse, and existing lock Figure 3.

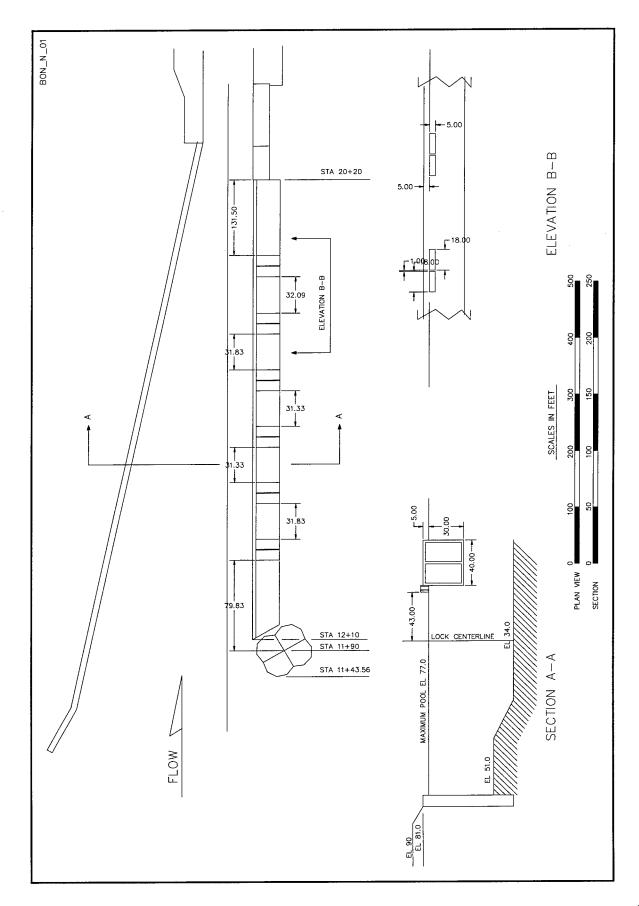
Figure 33. Plan F, plan and section, floating guard wall

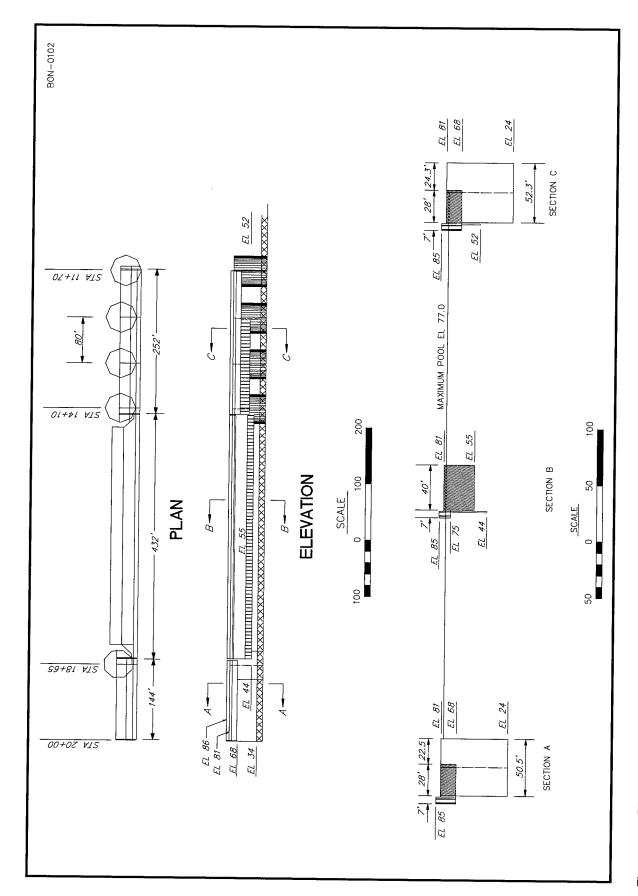
Figure 35. Plan F-1, plan and section of floating guard wall

Plan F-1 (Figures 34 and 35) was the same as Plan F except the guard wall of the new lock was modified to an 830-ft-long combination fixed/floating guard wall. The upstream 252 ft of the guard wall was attached to four 52.3-ft-diam cells to provide a rubbing surface for a tow using the wall. A 144-ft-long wall section adjacent to the lock was fixed and spanned from the lock wall to a 52.3-ft-diam cell at sta 18+65. A floating wall design was used for the 432-ft-long mid section and was anchored between two 52.3-ft-diam cells at sta 18+65 and 14+10. The fixed part of the wall was 28 ft wide and 13 ft deep with a top elevation of 81.0. The bottom of the fixed walls was at el 68.0. The floating part of the guard wall was 40 ft wide and 26 ft deep and floated with the bottom of the wall 22 ft below the water surface. A skirt with vertical slots was suspended from the fixed part of the guard wall between sta 14+10 and 12+50 and from the floating section of the guard wall. The bottom of the skirt attached to the fixed part of the wall was at el 52.0 and the bottom of the skirt attached to the floating part of the wall was 37 ft below the top of the wall or 33 ft below the water surface. The vertical slots were 1 ft wide and extended from the bottom of the wall to the bottom of the skirts. The vertical slots were spaced 6 ft center to center.

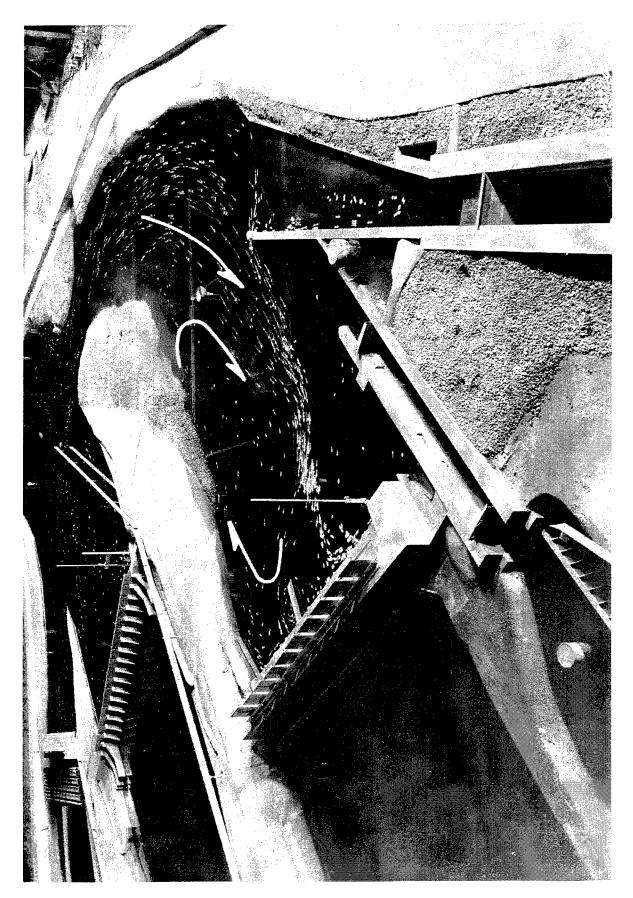
Photo 1. Original design, looking upstream, confetti showing current pattern in lock approach

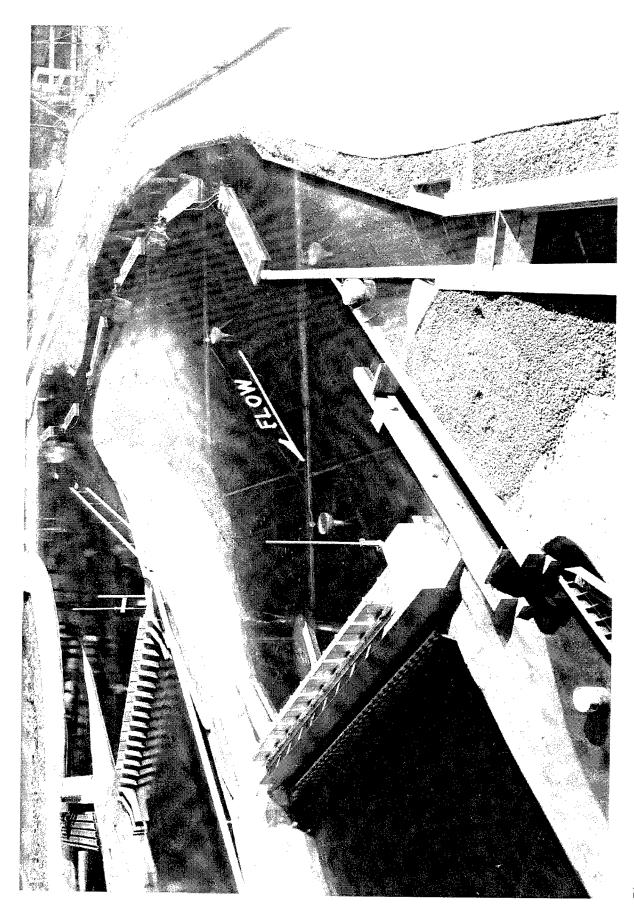
Photo 2. Original design, looking upstream, showing path of downbound tow approaching lock

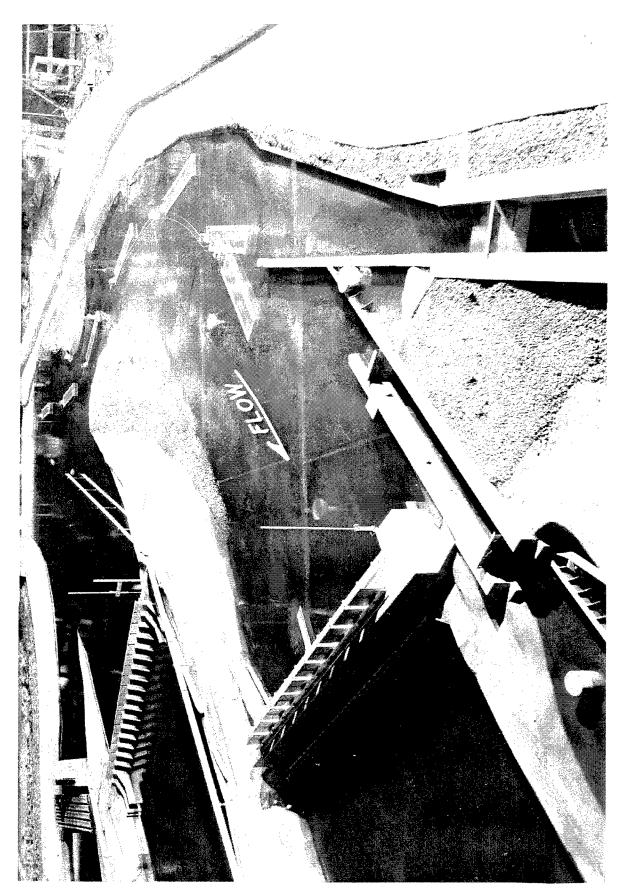
Photo 3. Original design, looking upstream, showing path of downbound tow approaching new lock

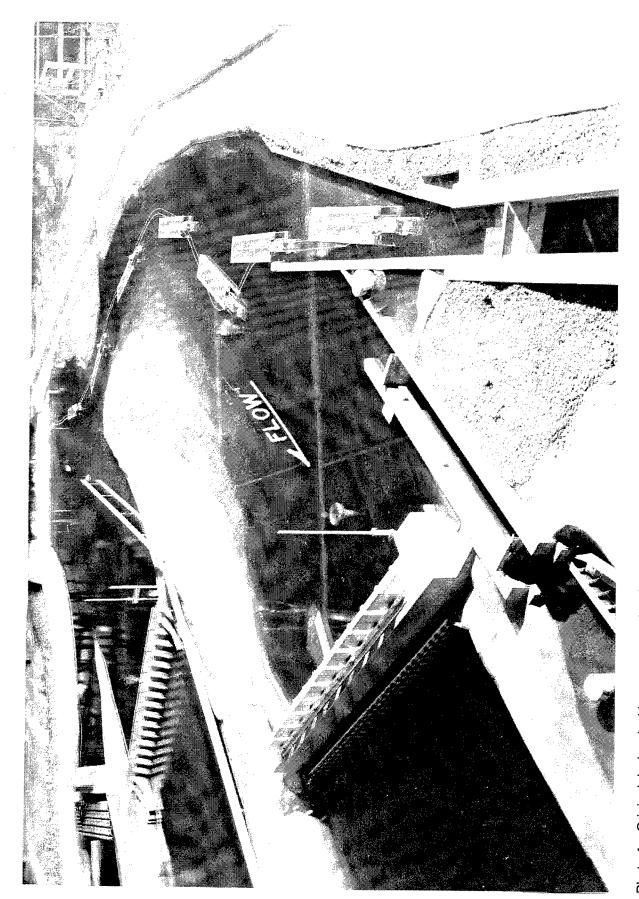
Photo 4. Original design, looking upstream, showing path of tow leaving new lock

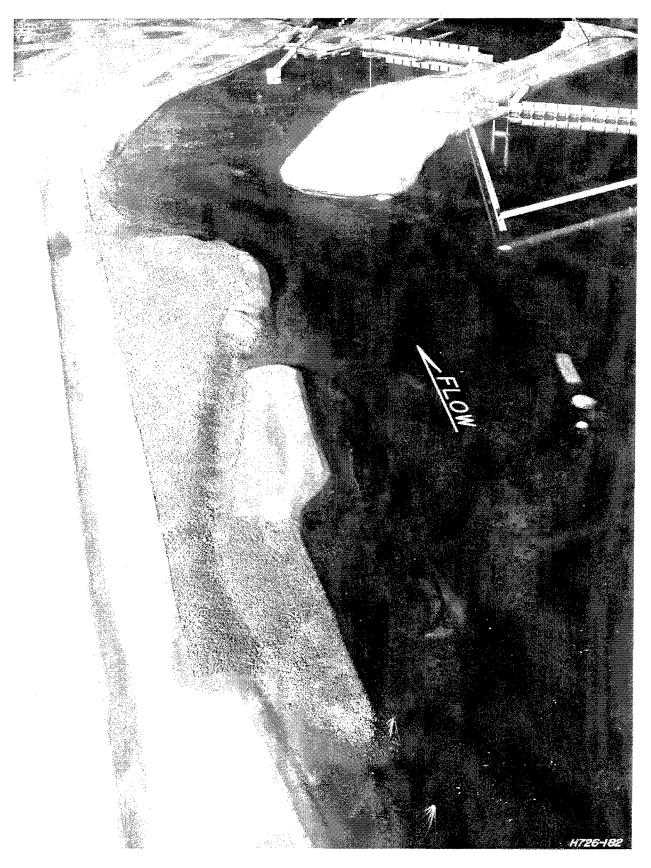
Photo 5. Plan F, looking downstream showing channel alignment

Plan F (Figures 32 and 33 and Photos 5 and 6) was similar to Plan D and was the same as existing conditions, except for the following major changes or components:

- h. A 50-ft-diam protection cell was placed along the left bank of the canal near the river channel.
- i. A fill with top el 81.0 was placed along the left bank upstream of Eagle Point. A berm located near the upstream end of the fill with top el 51.0 allowed tows to use the existing mooring dolphins. The fill was designated Goose Island (see Photo 5).

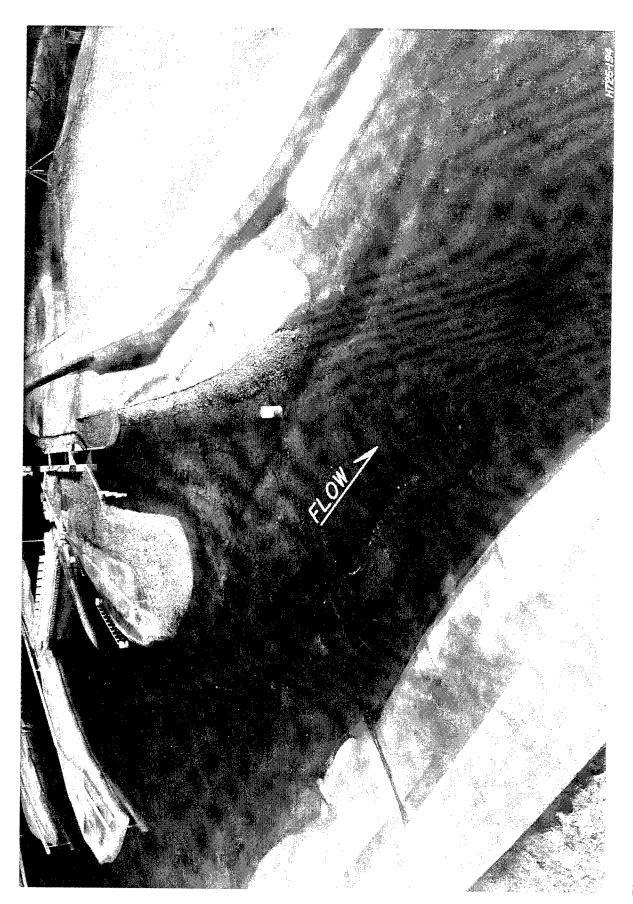
Photo 6. Plan F, looking upstream, showing lower approach of new lock

- g. A 250-ft bottom width lock canal at el -17 with 1V on 2.5H side slopes; the right descending canal bank was excavated on a 296-ft radius beginning at sta 48+00 to provide a wider entrance to the canal (see Photo 6).

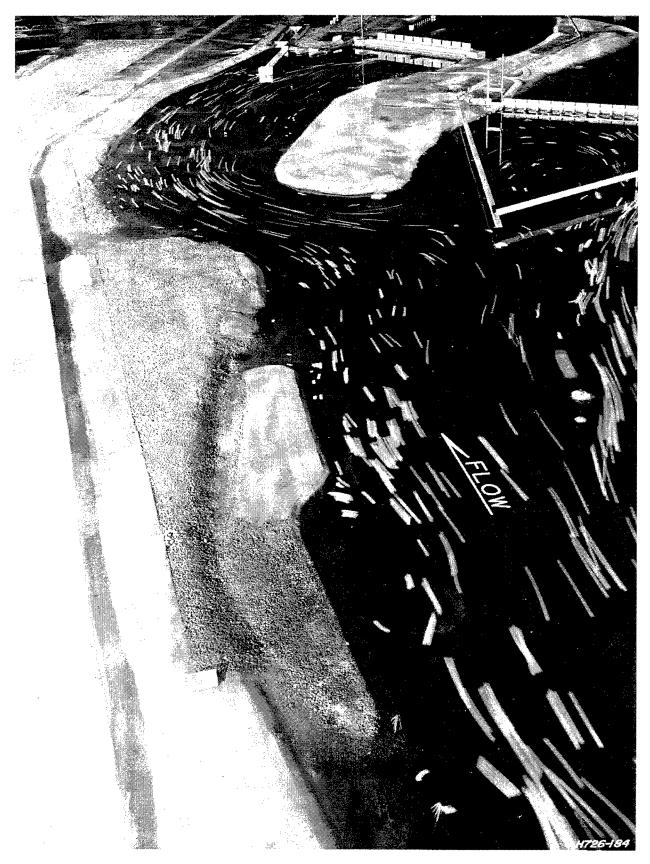
Photo 7. Plan F, 335,000 cfs, looking downstream, confetti showing current pattern

Current directions and velocities. Current direction and velocity data shown in Plates 74 - 81 and confetti shown in Photo 7 indicate the current generally parallels the left bank with a separation of flow occurring near the riverward ends of the submerged dikes. The currents approach the floating guard wall at a maximum angle of about 20 deg. The maximum velocities that would affect a tow approaching the lock varied from about 0.9 to 6.4 near Goose Island and Eagle Point and about 0.5 to 5.0 near the upper end of the guide wall for riverflows ranging from 70,400 to 660,000 cfs. The submerged dikes in the approach to the lock, along with the excavation of Bradford Island and Eagle Point, improved the alignment of the current in the new lock approach, reduced the outdraft near the upper end of the guard wall, and somewhat reduced the concentration of flow along the left bank upstream of the lock as compared to the original design. Goose Island reduced the size and intensity of the large eddy along the left bank immediately upstream of Eagle Point and improved flow conditions approaching Eagle Point, particularly during the higher riverflows. The currents near the downstream end of the lower lock canal generally align parallel to the left bank of the river channel; however, due to the alignment of the lower lock canal, the currents move past the entrance to the canal at an angle (Photo 8). A large low-velocity eddy formed in the canal entrance with all flows tested. With the 142,400-cfs flow, when the first powerhouse was discharging 140,000 cfs, the eddy extended into the river channel and upstream along the bank. The maximum velocity of the currents affecting a tow entering or leaving the canal varied from about 3.2 to 10.6 fps near the entrance of the canal and about 3.8 to 14.2 fps near Tanner Creek with riverflows ranging from 70,400 to 660,000 cfs.

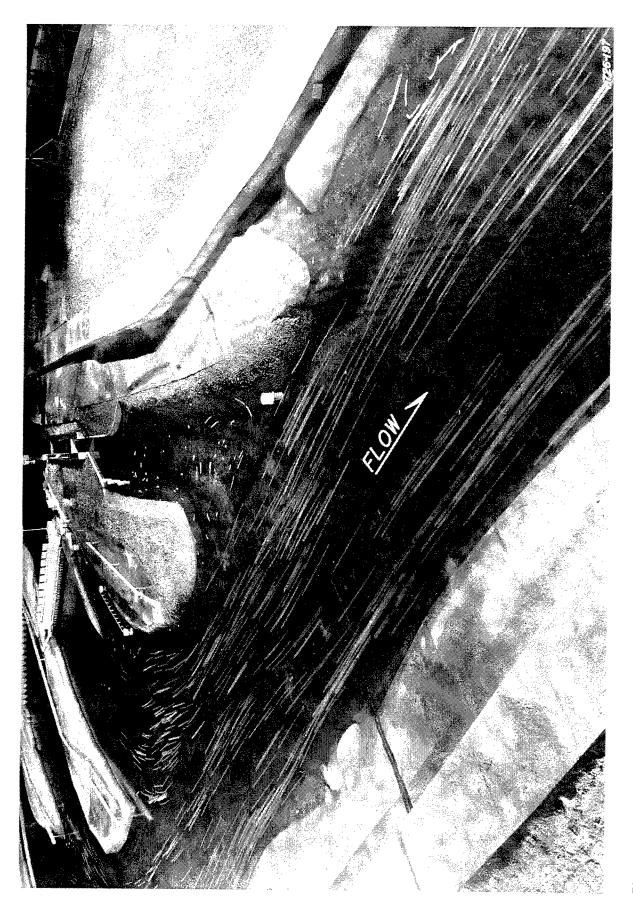
Photo 8. Plan F, looking upstream, 335,000 cfs total riverflow, confetti showing current pattern in vicinity of lock canal

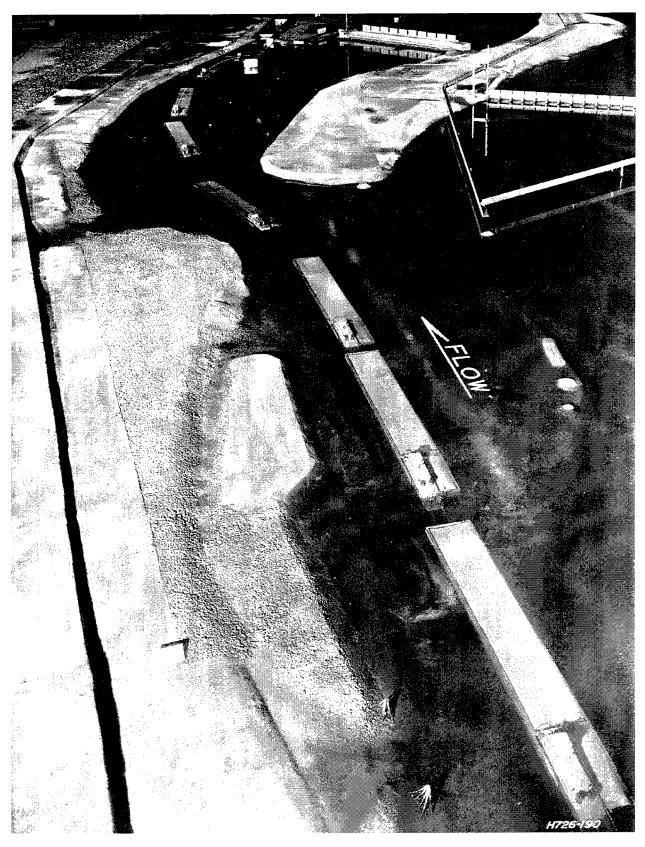
Photo 9. Plan F, 335,000 cfs total riverflow, 140,000 cfs first powerhouse discharge, looking downstream, showing path of downbound tow approaching lock

the left turn downstream of the point and approach the lock without difficulty with riverflows up to 335,000 cfs (Photo 9). With riverflows between 335,000 and 485,000 cfs, the distance riverward of Eagle Point from which a downbound tow could safely approach the lock was reduced to about 200 ft or less depending on the angle of the tow with respect to the current alignment as it approached Eagle Point. To ensure safe navigation conditions, a downbound tow should move as near Goose Island and Eagle Point as practicable. The greater the distance between Eagle Point and a downbound tow, the greater the angle of turn to the left a tow would have to make just downstream of the Point in order to properly approach the lock. The larger the angle of turn the tow has to make, the greater the exposure of the tow to crosscurrents and the greater the tendency for the tow to be rotated counterclockwise and miss the approach. Due to the relatively short distance between Eagle Point and the lock, it is important for a downbound tow to become properly aligned with the currents and to be close to the left bank and over the submerged dike field as far upstream as possible to safely approach the lock. A tow misaligned or too far from the left bank would be in danger of colliding with the guard wall or missing the lock and going into the powerhouse. Due to the general bed configuration and the division of flow in the area approaching Eagle Point, flow conditions were very erratic with the 660,000-cfs riverflow. This resulted in unstable navigation conditions which could make it hazardous for downbound tows to attempt to approach the lock at this discharge.

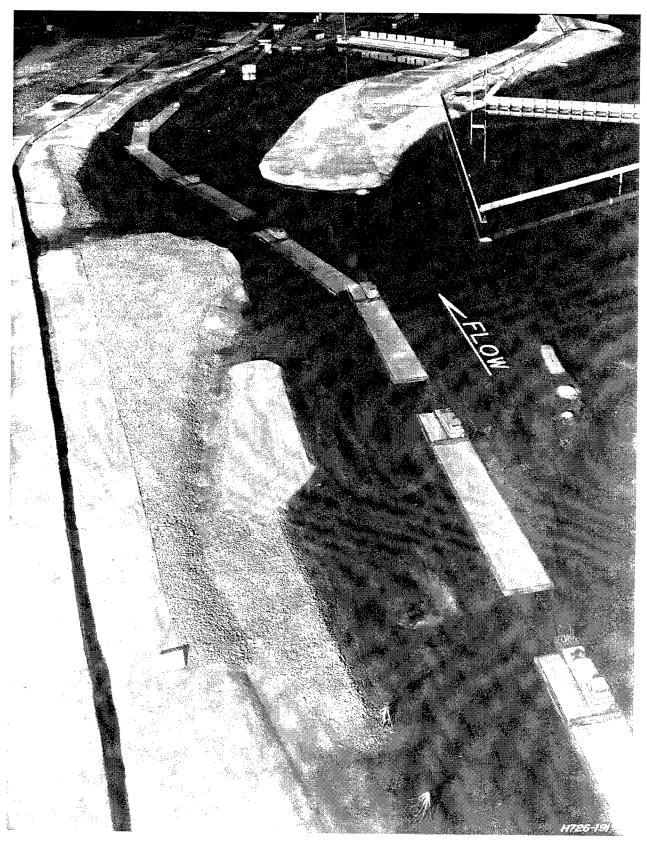
Photo 10. Plan F, 335,000 cfs total riverflow, 140,000 cfs first powerhouse discharge, looking downstream, showing path of upbound tow leaving the new lock

Upbound tows with sufficient power to maintain headway and steerage could leave the lock and move through the reach without any major difficulty with all flows tested, provided they exercise caution passing Eagle Point with the higher riverflows (Photo 10). During periods when the first powerhouse is discharging 140,000 cfs, upbound tows should exit the lock forebay along the landward guide wall and the left descending bank. Tows leaving the forebay along the floating guard wall would be in danger of being rotated around the upstream end of the wall. There was some indication that with the higher first powerhouse discharges, tows may experience some difficulties maneuvering in the lock forebay to exit along the landward guide wall.

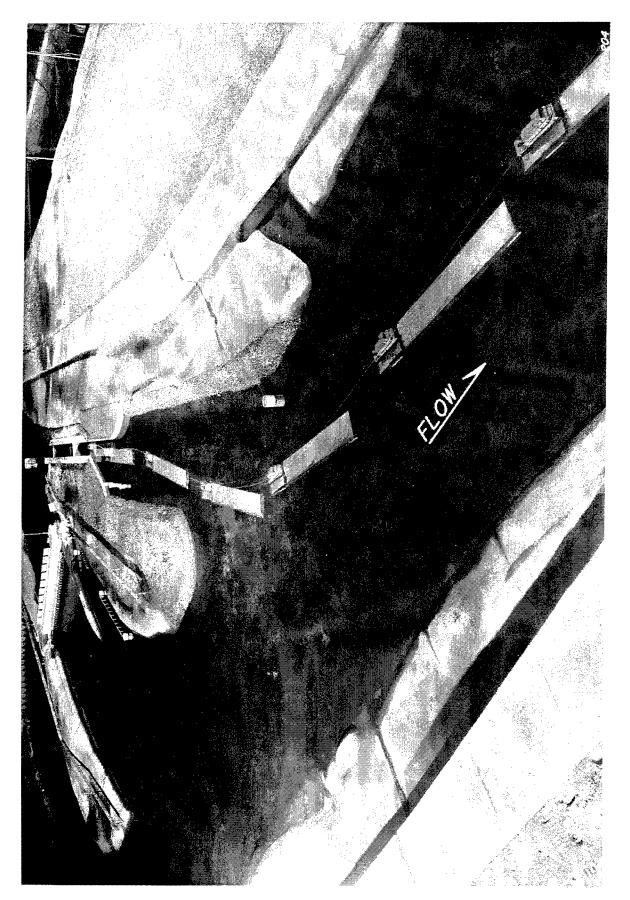
Photo 11. Plan F, looking upstream, 335,000 cfs total riverflow, showing path of downbound tow leaving new lock

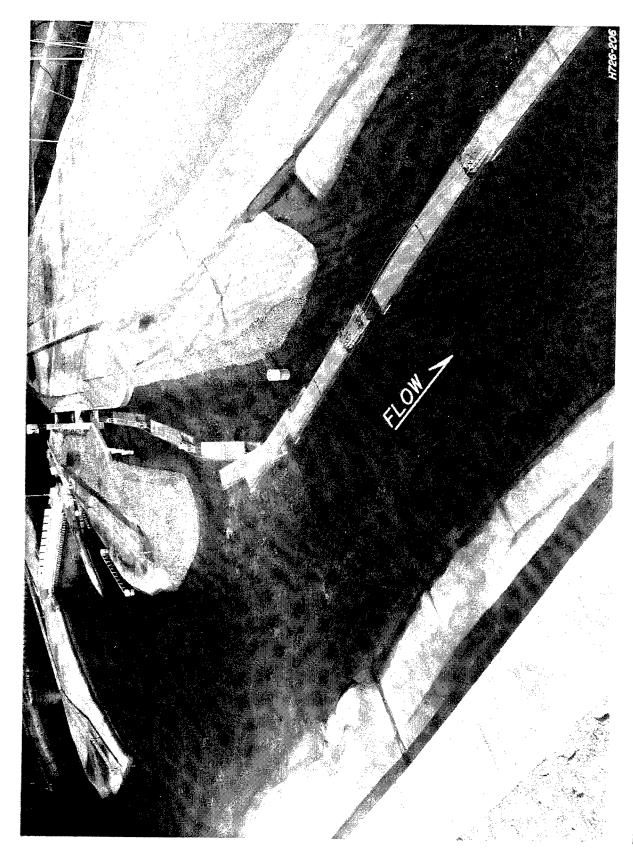
Photo 12. Plan F, looking upstream, 335,000 cfs total riverflow, showing path of upbound tow approaching the new lock

Satisfactory and safe navigation conditions were obtained in the downstream approach to the new lock with all riverflows tested up to 485,000 cfs, provided tows exercise caution entering and leaving the downstream lock canal. Downbound tows could exit the downstream lock canal without major difficulties with riverflows up to 335,000 cfs (Photo 11). As the riverflow increased to 335,000 cfs, there was a tendency for the tow to be moved downstream toward the protection cell along the left bank of the canal as the tow moved into the river channel. However, tows could move along the right bank of the lock canal and enter the river channel well upstream of the protection cell. As the riverflow increased to 660,000 cfs, the tendency for a downbound tow to be moved toward the protection cell increased and conditions could become hazardous for tows leaving the lock canal. Navigation conditions for upbound tows approaching the new lock were satisfactory with riverflows up to 335,000 cfs, provided the tows exercise some caution maneuvering to enter the lock canal (Photo 12). The right turn from the river channel, where the currents are parallel to the river channel,
